Conservation Statement for  
**St Monans Auld Kirk, St Monans**

Munro Allison Architects, Edinburgh

June 2024

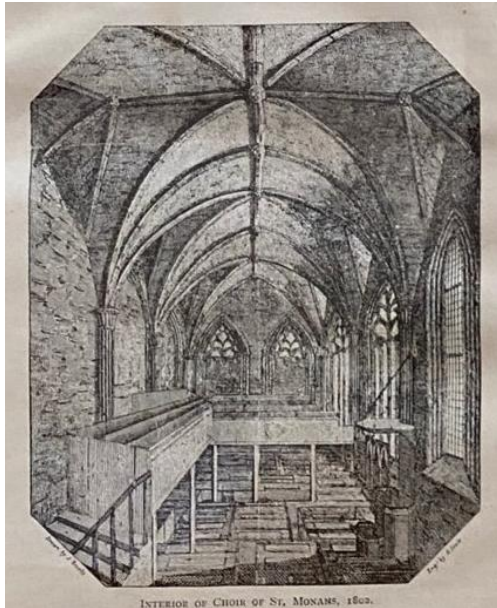
Fig. 6: Print view of interior, from Aberdeen Ecclesiological Society

The galleries are shown on what appears to be the only pre 1820s interior image (fig.6). This gives us a good indication of how the reformation church was set out, with the pulpit siting centrally on the south wall of the main space, with galleries to the north and east. A surviving remnant of galleries is kept within the Kirk (fig.7). Because of the view point taken, it is not clear whether there is also a west gallery under the tower but the view point is elevated: it would certainly explain why Burn had to rebuild the arch at the SW end of main aisle. Whether the tower at ground level was a separate enclosed space or part of main church, or had any openings to the transepts, is not recorded.

The blocking up of earlier windows would have been likely done when the galleries, or 'lofts', were installed within the church, and is confirmed by interior view c. 1802 (fig. 6), which shows not only the north but also the east windows blocked. There is also an external stair shown in figure 5. As these are usually for sailors (or other working class parishioners) these strongly suggest that there was a separate 'sailors loft'. The interior drawing doesn't seem to indicate any form of laird's loft, unless this was under the tower, although these are more commonly directly opposite the pulpit. However, the kirk session minutes refer to 'mending of ye window below superiors loft' in 1738, suggesting that there was a segregated loft, and one with a window below.

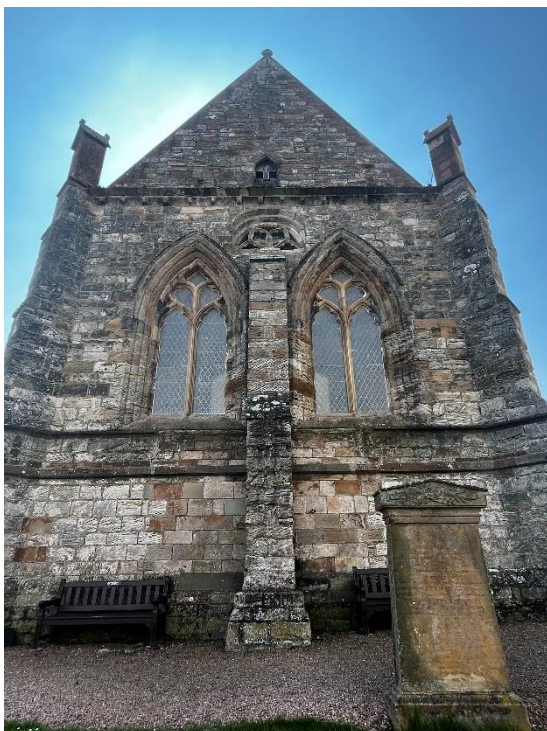
Fig. 17: East elevation

The masonry also suggests that the lower half (and some of the lower sections of window) are earlier (with lighter stone of squarer proportions), with the skewed buttresses, and upper section of wall being a later addition. There is also some colour banding of the window reveals, but whether this is deliberate, or an effect of alterations and repairs can't be confirmed, although the bands are often consistent across the windows.

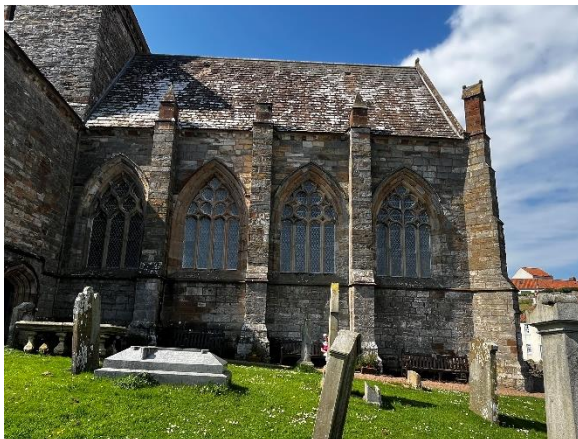
Fig. 19: South elevation

The choir elevation to the south is the most open within the whole building. There are four bays, each with a tripartite, pointed arched window, although the tracery for the western most is different to the others, which are the same pear drop type as on the east. The centre east window is important for dating as we know this was inserted by William Burn, so the soft red sandstone (which has weathered heavily) elsewhere can be attributed to him. It also has repairs by Steven Newsom (c.2006) so we also have a clue to the general appearance of the heavy repairs by MacGregor Chalmers. The entire wall has been heavily pointed with cementitious mortar.

Again, the masonry to the earlier pear drop windows suggests colour blocking, but not the eastern most. The corbels in the cornice block appear heavily restored, with plain quarter round mouldings generally on newer stones: the earlier stones are heavily eroded but suggested carving on at least some.

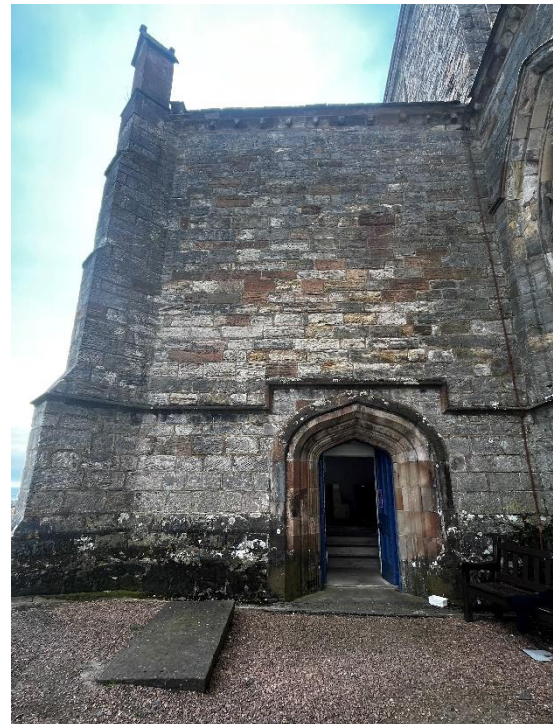
Fig. 22: South transept- east elevation

This is a relatively plain elevation, with an 1827 door inserted. The joinery was replaced by Ian Lindsay, with arched framed four panel leaf and studded decoration. Again, the masonry is consistent with the red/ ochre sandstone being a Burn intervention.

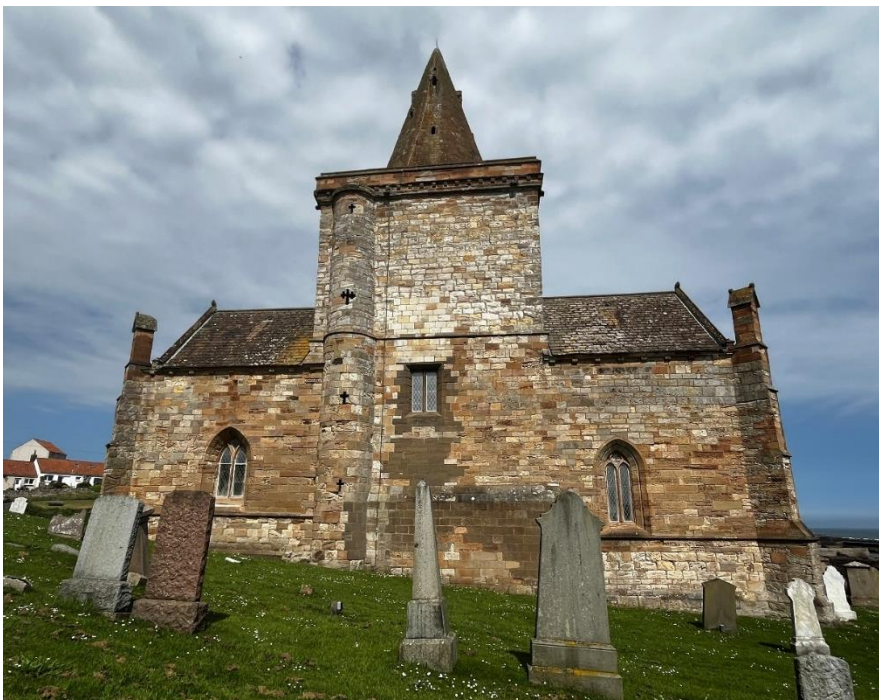
Fig. 25: West Elevation

The west elevation is generally blank masonry, with a few smaller windows, one into each interior space. These are generally simple, without elaborate tracery, and each of a different design. The elevation is dominated by the central tower and its projecting stair tower. The masonry is generally of the white sandstone type with identifiable bands of replacement and repair, most concentrated in the centre bay (owing to fenestration changes) but also in the upper section of the south end.

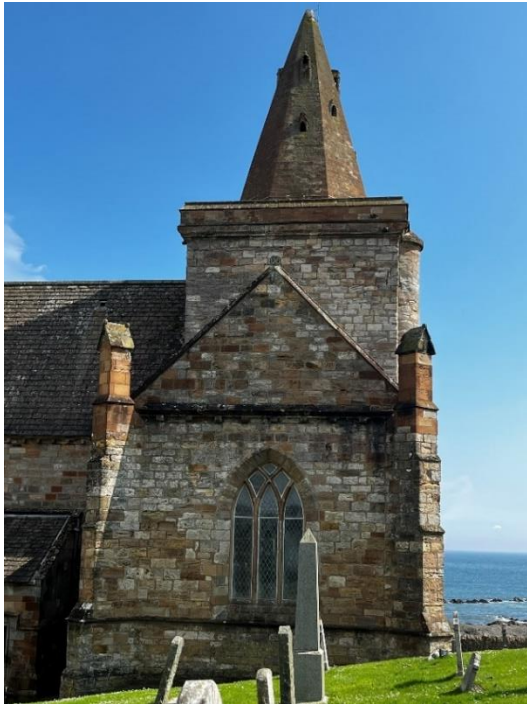
*Fig. 30: North elevation- north transept*

As on the west, there is a triangular section of masonry in red sandstone at high level, and the top-most few courses have been renewed, including most of the cornice and corbel course.

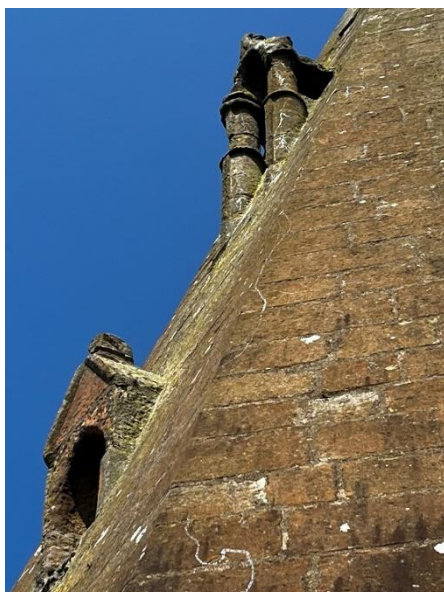
<Fig. 34:  
Spire lucarnes

Externally the spire has a consistent appearance to each side, apart from location of lucarnes. It is built from a darker sandstone than the tower, but there have been some adaptations in the louvred openings, with one being removed.

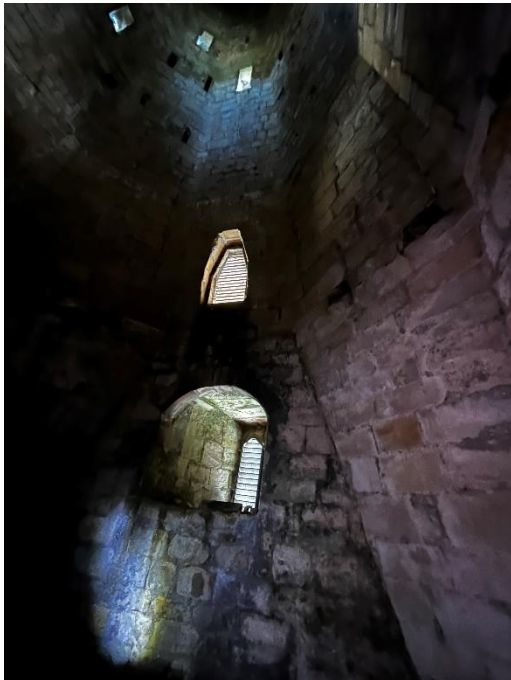
*Fig. 40: West wall of upper tower room*

The upper tower room sits within the spire and is accessed via the turnpike stair in the west elevation. It starts from a square floor plan and uses exposed stone spandrels starting just above existing floor level and rising to create the eight-sided polygon spire. It has a modern timber boarded floor and floor structure. All wall surfaces are exposed stone, with a pointed arch entrance to the tower stair which cuts into the north west spandrel, and a shallow arched window opening with deep, canted reveals on the SW elevation (c. 1950). There are also two small openings at high level, and smaller lucarnes immediately above. All of the larger openings are louvred and wired.

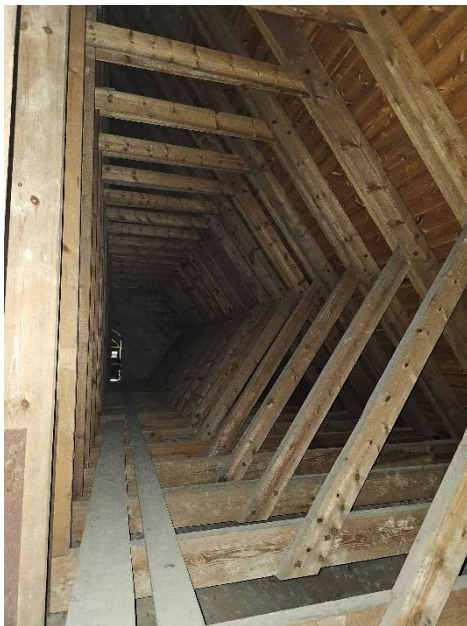
<Fig. 42: Attic over choir vaults

The attic space above the choir could not be safely accessed or fully inspected owing to safety and poor lighting. However, a limited visual inspection from the access point showed a fully replaced and relatively modern (rip sawn timbers) timber roof construction, sitting over the parged upper surface of the stone vaults.

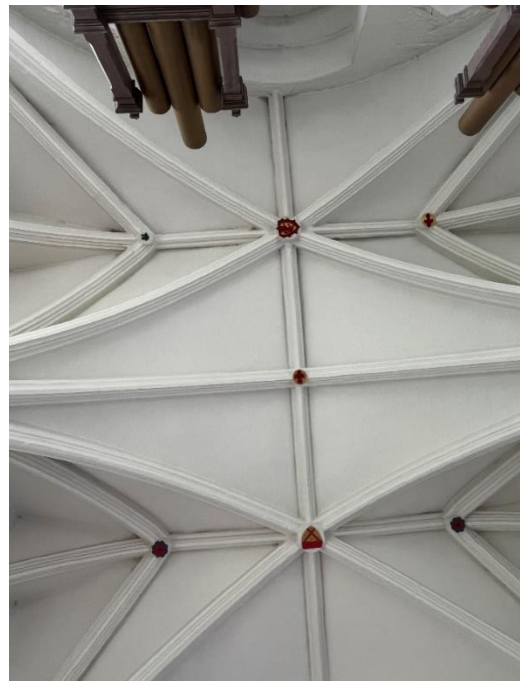
>Fig. 52: Choir Vaulting

The choir ceiling is the most magnificent part of the Kirk: it is vaulted, in four bays, whose supporting ribs descent into the walls below. There are painted bosses at each intersection, painted with the coats of arms of various local families. One was formerly used for hanging the votive ship before the Burn alterations.

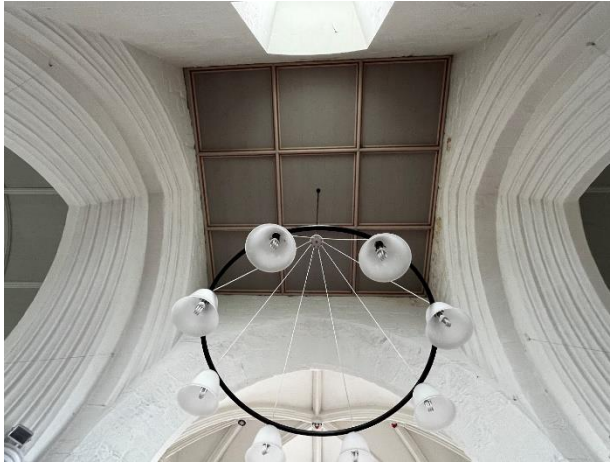
^Fig. 53: Crossing Ceiling

The crossing ceiling is made from flat timber, with applied mouldings, picked out in colours. This was a modern insertion by Ian Lindsay who had removed the plaster vaults fitted by Burn and shown on his drawings (fig. 8). The height of the ceiling was also changed, presumably to account for the revised west window.

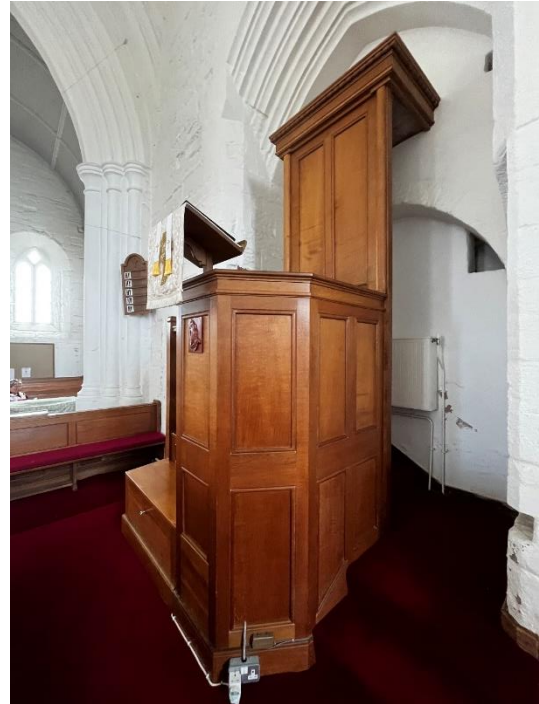
>Fig. 54: West wall of crossing with pulpit and new archway

Again, this wall has been much altered. Burn's elongated central window was removed by Ian Lindsay who partially reinstated a version of the earlier west entrance, with a smaller window above this. The actual design of this is awkward with voids to the outer stonework visible and the pulpit feels oversized for the opening.

The pulpit (fig. 54) and communion table were designed by Ian Lindsay, presumably to fit into the newly restored west arch. They are relatively plain.

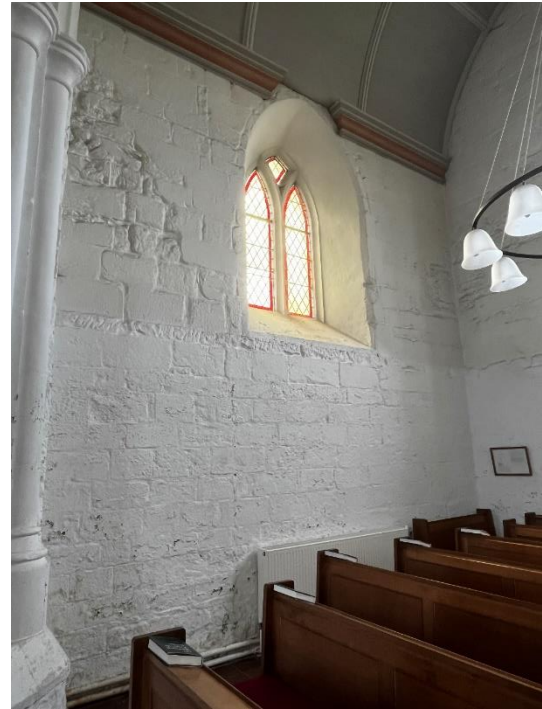
Fig. 56: North transept, west wall

This is relatively plain masonry elevation with a single window, with deep plain rebates and a leaded light, with generally clear glazing and a red glass border. This sits just above a string course which appears to have been cloured back. To the south of the window, the stone above the string course has a definite diagonal band of more decayed stone: this may be where a wall was taken up, or a remnant of earlier wall indented both above and below: the masonry is certainly of nineteenth century proportions (as opposed to below the string course which is generally more square. A similar pattern appears externally and also to the north side internally, to a lesser degree.

There is also a small high level indent to stone just to upper wall on left of window with perpendicular joints above and below. The cornice (timber?) sits awkwardly around the window's pointed arch. There is a modern steel panel radiator fitted centrally to wall, fed by surface pipes going around perimeter of transept at low level.

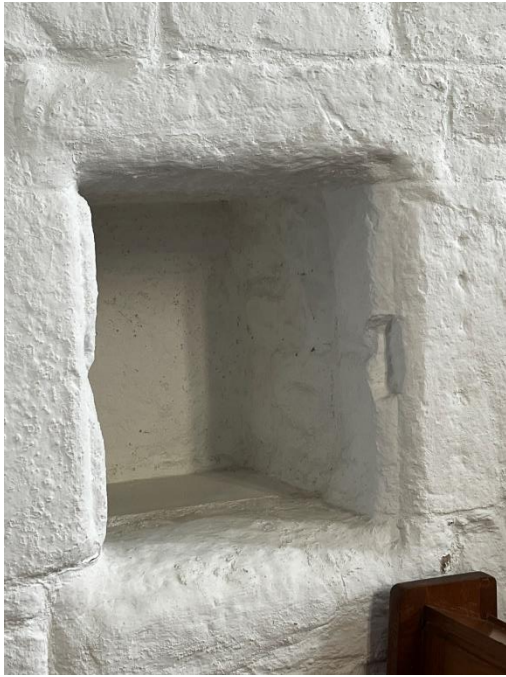
Fig. 61: South transept, Aumbry in east wall

Most of the stonework below the string course is hidden behind notice boards, but the stones above are generally less weathered than those of the east. There is also a small piscina type structure again in the east corner, with a deep recess to front and (drain?) hole in centre. This has a similar moulding and profile to that in the north transept but is in considerably more worn condition.

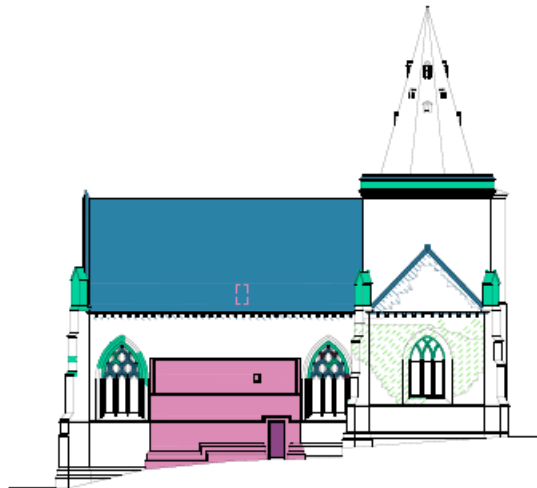
EXISTING NORTH ELEVATION: 1:100 at A1

Fig 73: Approximate Dating Information for Elevations

The following drawings show the respective ages of elements of the building. We have noted those changes which we can evidence, either through documentary evidence or building analysis, but there is some earlier fabric that we have not dated (i.e. 14<sup>th</sup> or 15<sup>th</sup> century works) which remain white: the significance is unaltered whatever the case. Further archaeological investigation would benefit this understanding of earlier fabric.

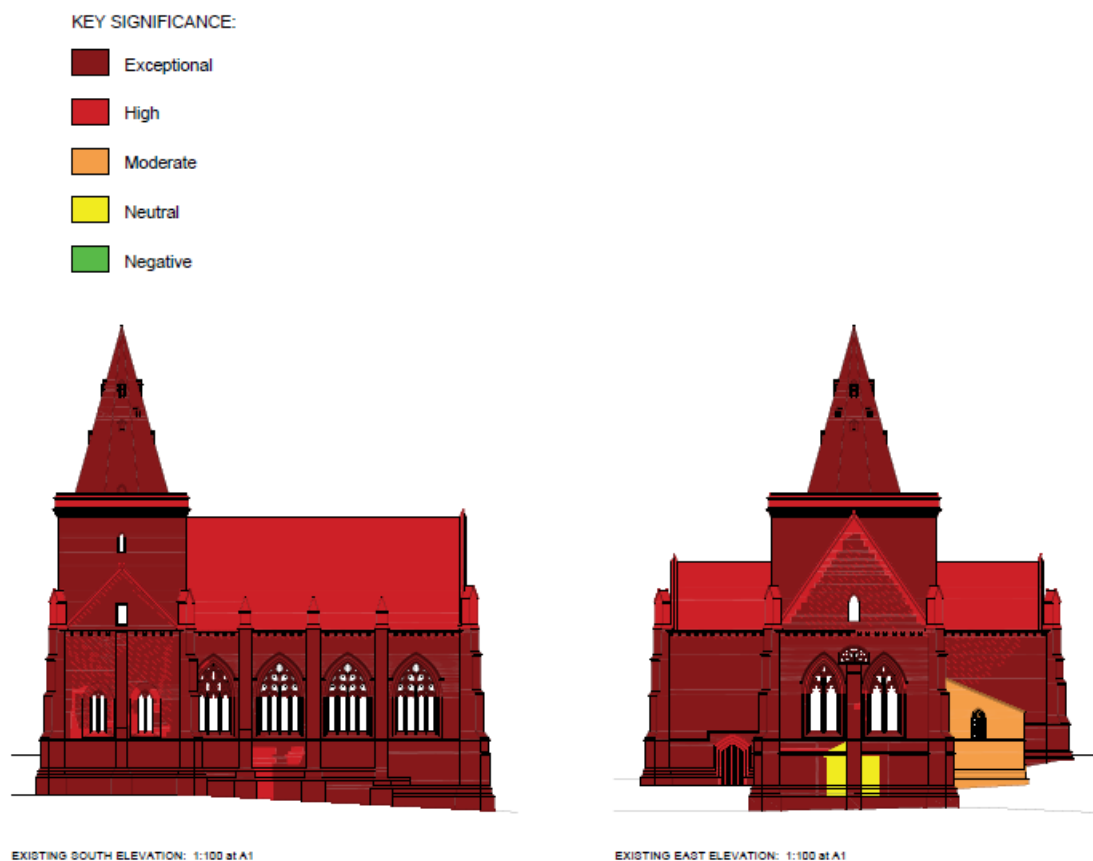
Fig 74: Significance Grading for South and East Elevations

- 4.3.1 St Monans Auld Kirk is of MODERATE to EXCEPTIONAL *architectural* significance: the individual level of each element's significance is shown below.
- 4.3.2 St Monans Auld Kirk is of EXCEPTIONAL *landscape landmark* significance and HIGH *cultural landscape* significance.
- 4.3.3 St Monans Auld Kirk is of EXCEPTIONAL *archaeological* significance.
- 4.3.4 St Monans Auld Kirk is of MODERATE to HIGH *interior design* significance.
- 4.3.5 St Monans Auld Kirk is of EXCEPTIONAL *historical* significance owing to use, importance to nation as well as parish, and as testament to religious/social history.
